**BAKER FLOODWATER RESERVOIR
SITE 6**

NH 00243

**PHASE I INSPECTION REPORT
NATIONAL DAM INSPECTION PROGRAM**

**JULY 1979
85 06 14 014**

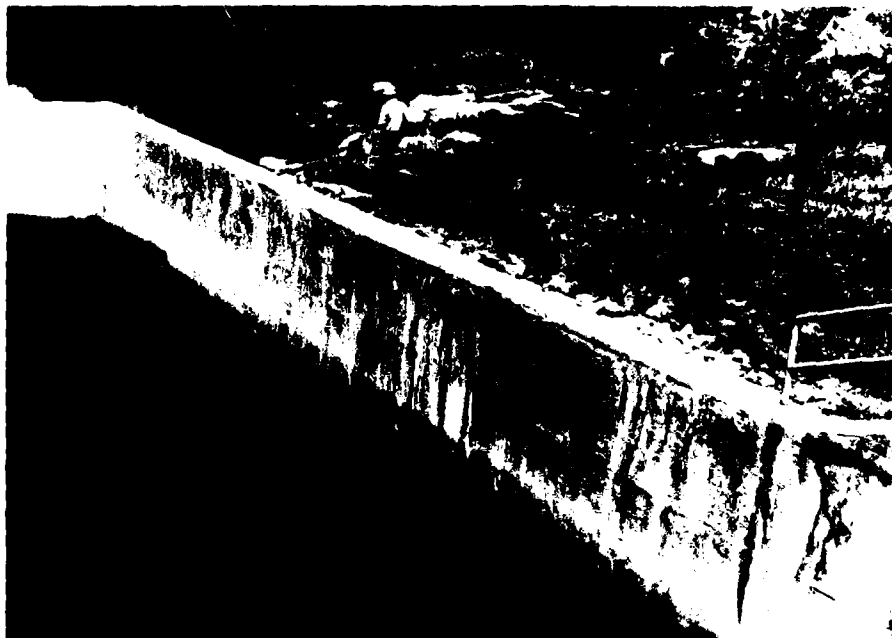
The high water table along the right training wall plus possible frost action due to the fines deposited in the back-fill along the wall may have caused the deterioration of the upstream right training wall. Photos No. 9 & 11 show the right training wall and Photo No. 10 shows the upstream left training wall for comparison.

c. Appurtenant Structure. The visual inspection of the concrete box spillway with high and low stage inlets, pond drain with a stop log control and the discharge sluiceway channel did not reveal any evidence of stability problems. The concrete surface and vertical alignment of the spillway structure are in good condition except for numerous vertical cracks, staining and deposit of efflorescence around concrete cracks as shown in Photos No. 9 & 10.

PHOTO NO. 10 - Left upstream wall of spillway.

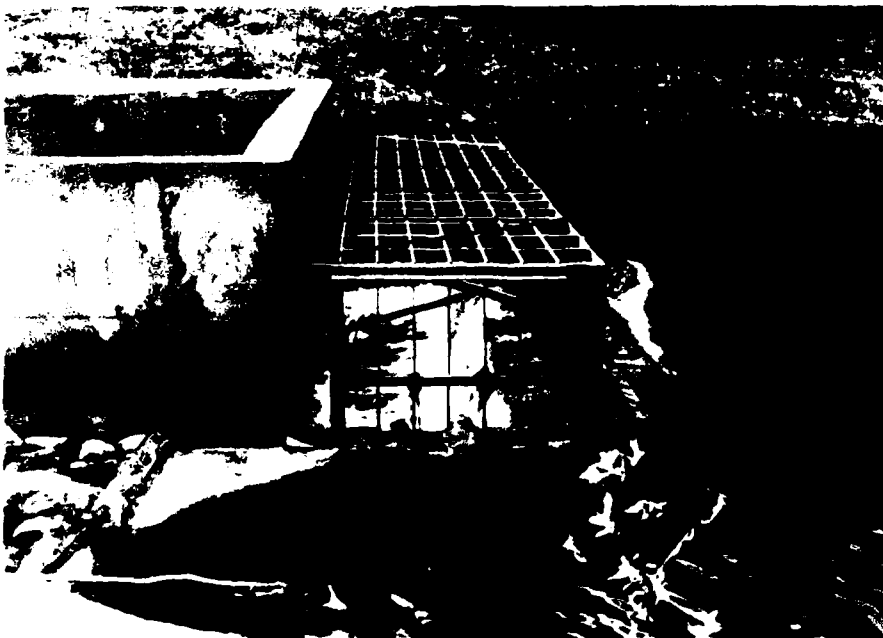
The galvanized trash rack at the low stage spillway crest consists of structural steel shapes. The trash rack assembly is in good condition, no rust or peeling of the protective coating was noted, see Photos No. 13 and 14. Debris was noted on the trash rack.

PHOTO NO. 14 - Detail of trash rack.
